EVALUATION OF THE STRUCTURAL RESPONSE AND FAILURE OF A FULL-SCALE STITCHED GRAPHITE-EPOXY WING

Dawn C. Jegley and Harold G. Bush
NASA Langley Research Center
Hampton, VA

Presented at the AHS Structures Specialists' Meeting
October 30-November 1 2001

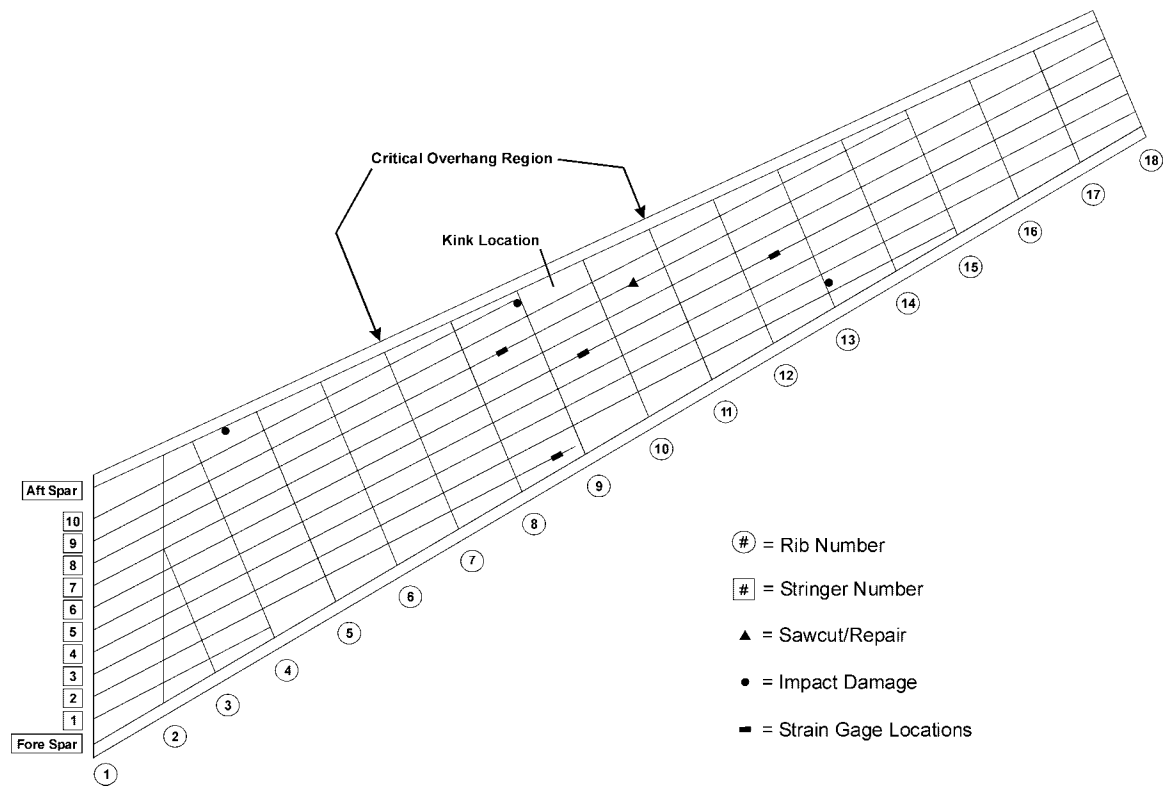
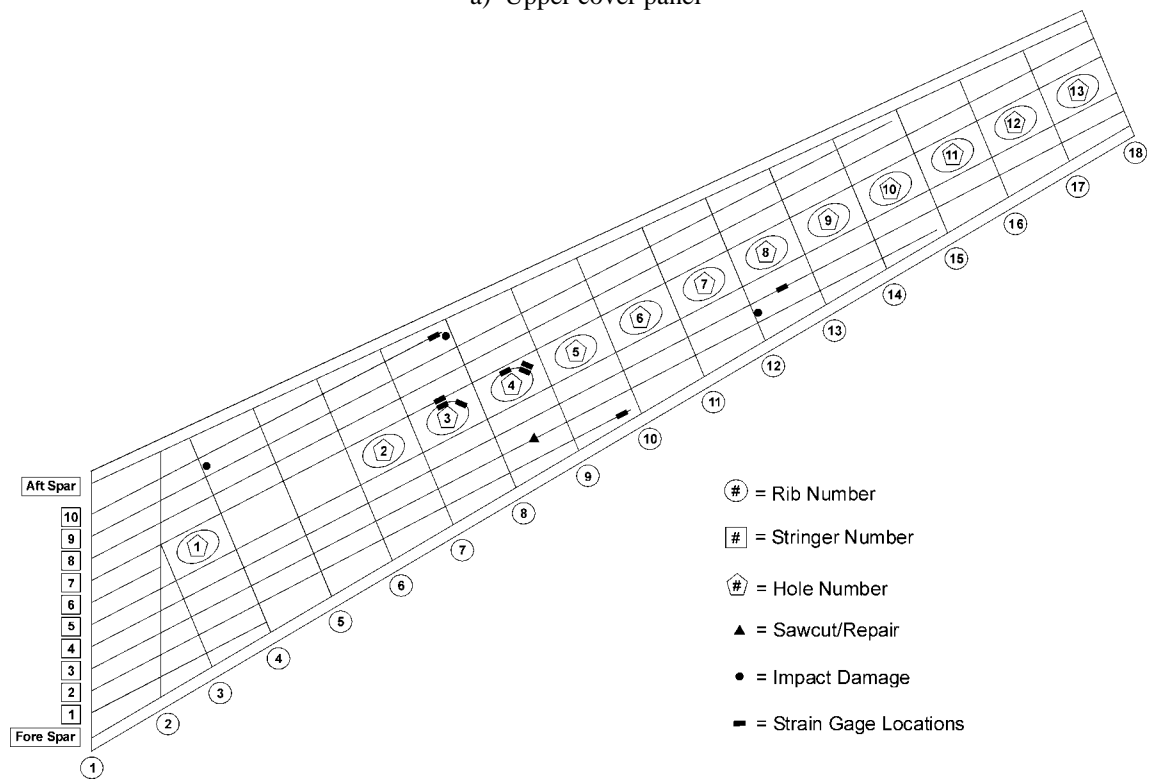
Fig. 2. Wing box upper and lower over panel configurations with strain gage locations.

The wing was subjected to discrete source damage in the form of seven-inch-long sawcuts to the upper and lower cover panels, as shown in figure 2. Each sawcut ran through two stinger bays and cut through a stringer. Metal patch repairs were used to restore the wing to full load-carrying capability. The damaged region was removed prior to implementing the repair. The repairs consisted of a metal plate which conformed to the wing surface on the outer surface of the cover panels and internally spliced stringers. All parts of the repair were attached to the wing with mechanical fasteners.

An overhang of the cover panels with a width of approximately four inches behind the rear spar left an unsupported edge along the length of the test article. This region is shown in figure 2a as the “critical overhang region.” A small initial geometric imperfection in the form of a kink in the upper cover panel was present in the as-manufactured structure. This kink is centered half way between ribs 9 and 10 and has a maximum depth of 0.1 inches. The kink was initially considered minor enough that it would not influence the cover panel structural behavior. However, since the kink is in close proximity to a stringer runout and is in the region of the upper cover panel that

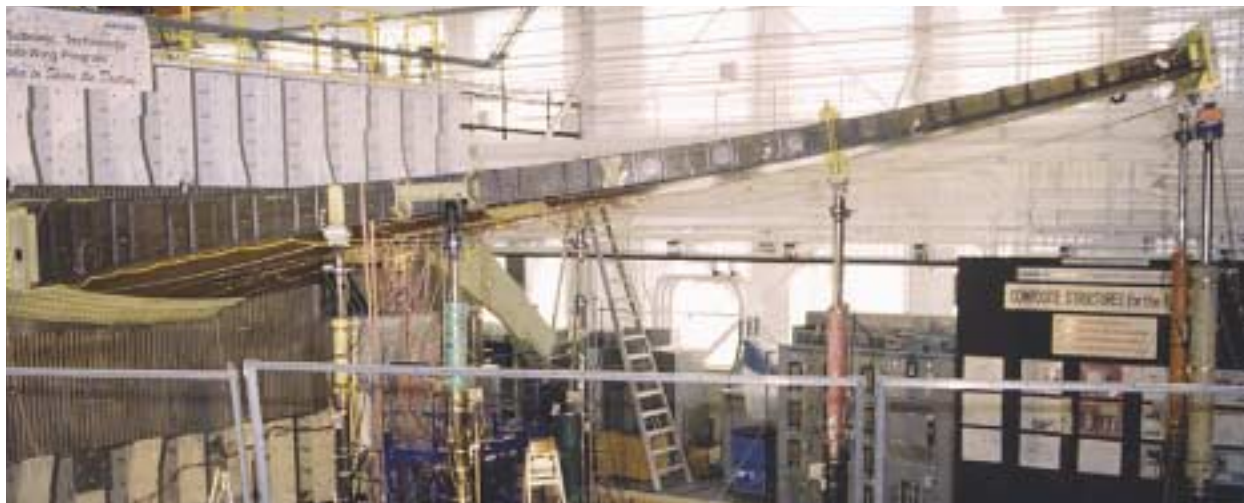
The test article supported 97% of its Design Ultimate Load (DUL) prior to failure in Test 8. Design Ultimate Load is 150% of Design Limit Load. A photograph of the test article loaded at 95% DUL is shown in figure 6.

Fig. 6. Deformed test article loaded to 95% of Design Ultimate Load.

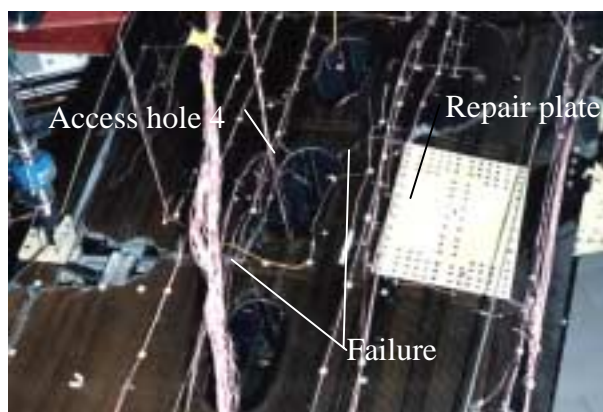
The primary failure location is across the lower cover panel through access hole 4. This region of the lower cover panel after final failure is shown in figure 8. The failure goes through all stringers but primarily remains between ribs 8 and 9. Both spars were also damaged. Other minor damage was found but appears to be unrelated to the initial failure event. The discussion of the failure will be limited to the regions between ribs 6 and 10.

Fig. 8. Failure across lower cover panel.

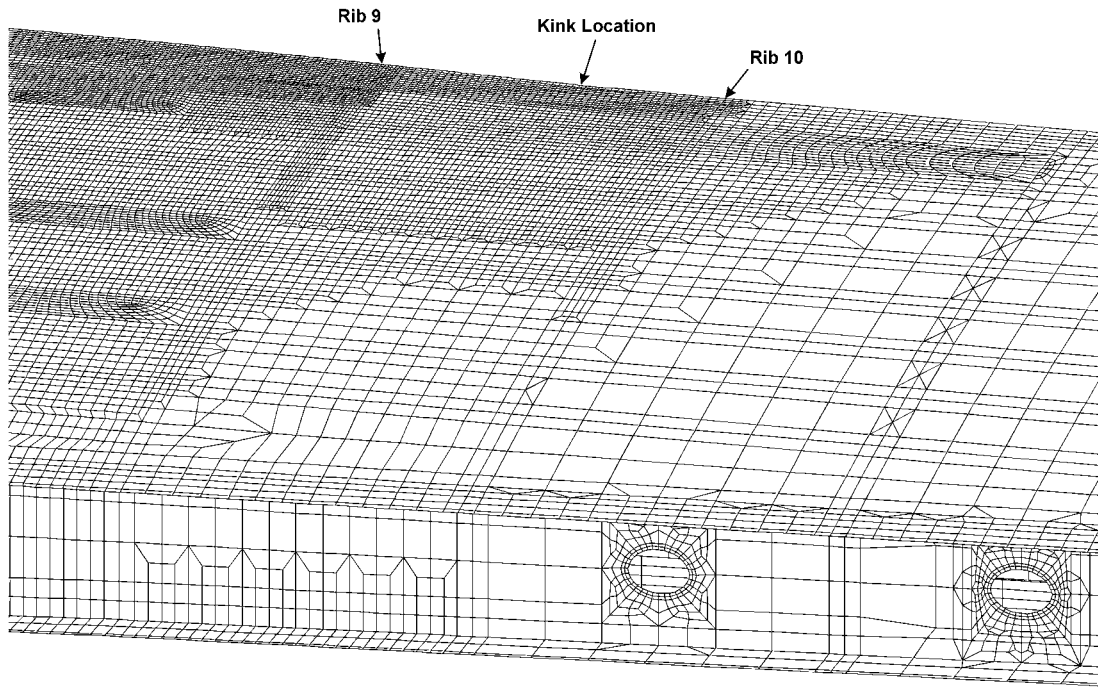
was included in the post-test finite element model. This local refinement is shown in figure 16. The kink is a geometric imperfection in the skin.

Fig. 16. Finite element model of kink region.

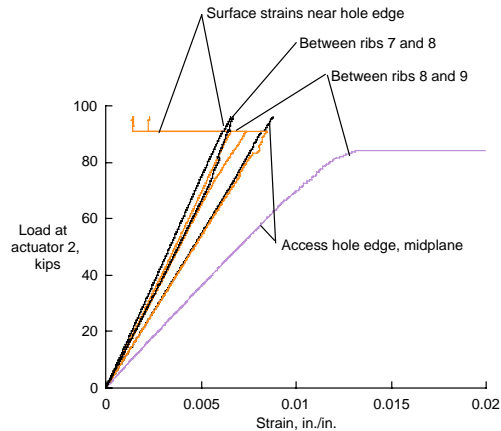
Strain gages at the edges of the lower cover panel access holes indicate high strains at these locations. Measured strains at the outboard, rear corner of access holes 3 and 4, between ribs 7 and 8 and ribs 8 and 9, respectively, are presented in figure 18. The strain gage locations are shown in figure 2b. Nonlinearity in the load-strain behavior can be seen at these access holes. The most significant nonlinearity is at the outboard corner of access hole 4. The largest measured strain is at this location and is approximately 0.0096 in./in. at DLL on the surface. Final failure of the cover panel ran through this location. Since analytical results to date do not adequately capture the failure, comparisons of these strains for the access hole edges are not done with experimental results.

Fig. 18. Measured strain results at the edge of critical access holes.
